CYCLE ACTION WAIHEKE

Pinch Point Hazard Areas To Cyclists On Waiheke’s Roads

From: The Cycle Action Waiheke Committee

Date: 19/09/2012

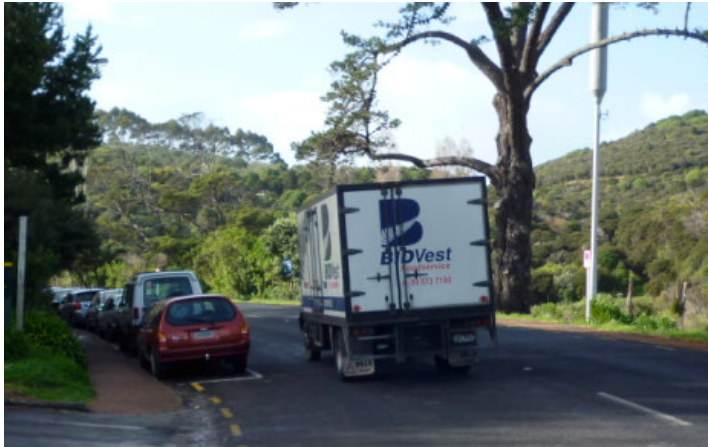
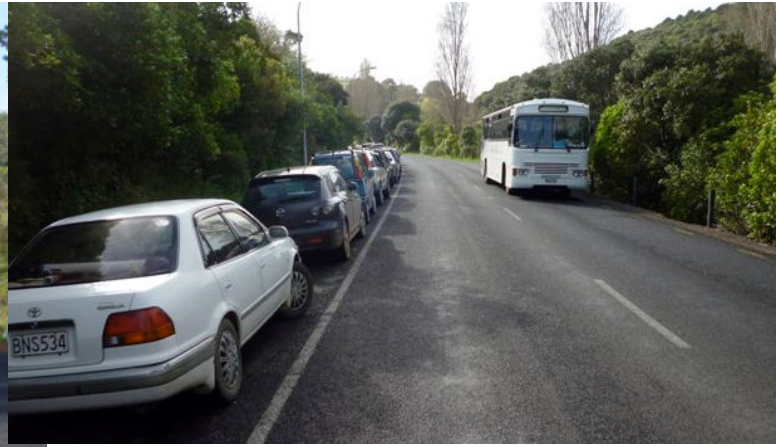
Action Priority Number: 1.

Location: Ocean View Road heading eastbound

Reason for pinch point(s): On street parking on side of the eastbound carriageway. Opening car doors

This area has been a persistent danger area for cyclists on Waiheke. CAW has presented and submitted to council on this problem a number of times. Cyclists are required to overtake parked cars on a blind corner and have the danger of car doors opening up on them for the full length of the on street parking. Drivers are often frustrated and undertake dangerous manoeuvres if cyclists are in the correct, centre of the lane position. Cyclists hugging the doors are extremely vulnerable to “dooring”

That the Waiheke Local Board request that AT carry out a safety audit on this area. That the relocation of all on street parking is considered. That widening the road by three metres is considered if parking is to be retained. This would allow provision of a cycle way on the inside (kerbside) of “floating” parking (Copenhagen cycle lane design). Alternatively designating the area 30 kph zone and add appropriate traffic calming including the marking of “sharrows” the full length of the hazard to encourage riders to avoid the door zone and drivers respect their centre of the lane positioning. See appendix at end of report for an explanation of sharrows.

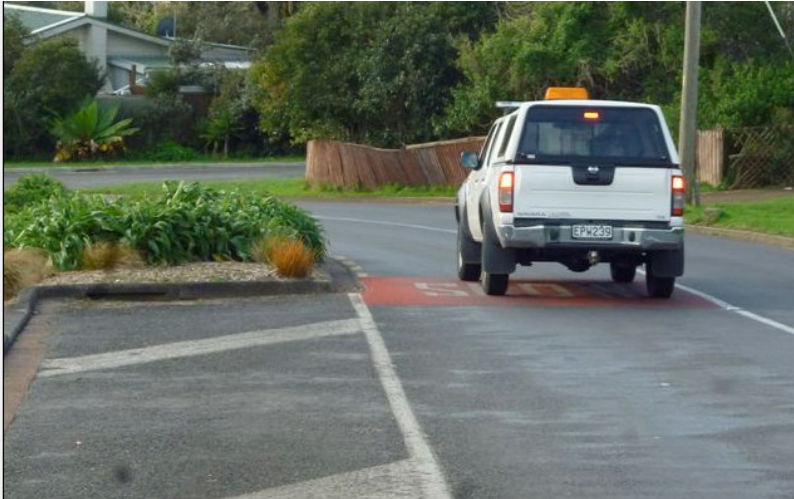
PINCH POINT ASSESMENT SHEET
Action Priority Number: 3.
Location: Miami Avenue- Entry to Surfdale shops heading westbound
Reason for danger: Planting bed and on street parking beyond that, narrow the carriageway.

As riders head down the hill into the village they are squeezed into the edging planter bed that acts as a traffic calming narrowing into the village. After that, parked cars in the angled parking area can back out into traffic to get better visibility before pulling out. Cyclists are squeezed into the rear of the cars.

That the Waiheke Local Board request that AT carry out a safety audit on this area. That the vehicle speeds before the current narrowing are significantly reduced using a speed table just past the entrance to Alison Rd as a "threshold" to the village (red painted SLOW thresholds are positioned too far into the village). That the vehicle speeds are maintained at under 30 kph from here through the village using a further speed table/pedestrian crossing in the village (with cyclist bypass lanes if this includes kerb extensions). That the planter narrowing is maintained as it helps slow speeds but that sharrows are painted on the downhill lane running up to it and through the village. That the angled parking is changed to "reverse in" angled parking Known to be safer for cyclist but no loss of parking. That the footpath though the shops is widened by a further 1.8 metres to create a separated cycle way to avoid the road- This last idea may require re-alignment of the road and loss of some on street parking on the Northern side of the road.

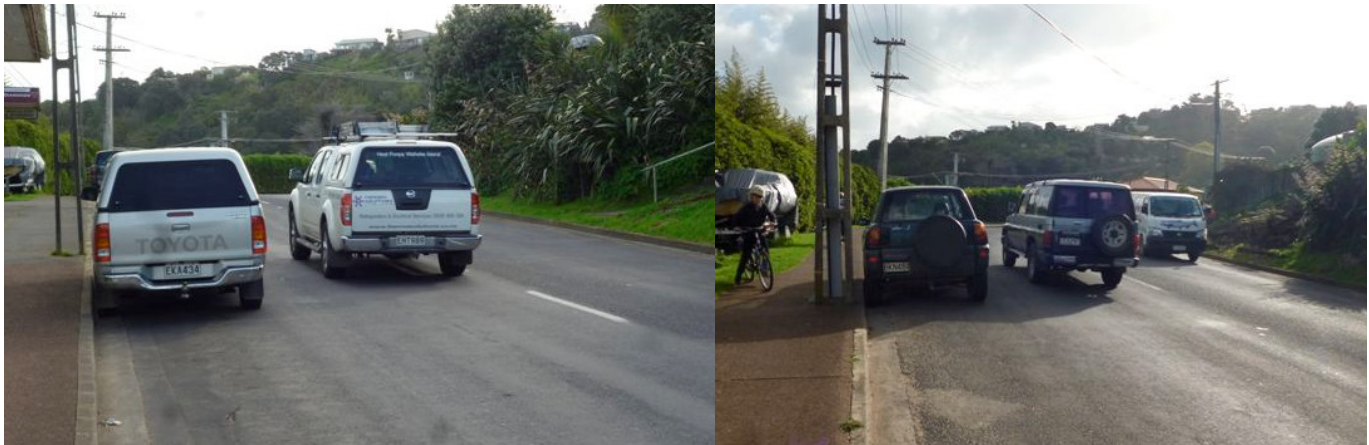
PINCH POINT ASSESMENT SHEET
Action Priority Number: 4.
Location: Hamilton Rd- Entry to Surfdale shops heading westbound
Reason for danger: Parallel on street parking creates a pinch point and dooring hazard

As riders turn into Hamilton road from Miami Avenue they are squeezed into the rear of parked cars and their door opening zones due to on street parking next to a very narrow vehicle lane.

That the Waiheke Local Board request that AT carry out a safety audit on this area. That the vehicle speeds before this point are significantly reduced using a mini roundabout or much reduced kerb radii at the Hamilton/Miami Avenue intersection. That the on street parking between the Hamilton Rd/Miami Avenue intersection to the corner just before the Blake St intersection is removed to allow a wider live lane possibly with a narrow cycle lane. That the footpath past the shops is widened by 1.8 metres to create a separated cycle way to avoid the road. Important – at least two parking spaces could be dedicated to the Jewellery shop users on the wider corner before the Blake St intersection. Also three of the nearest car park spaces in the car park could be dedicated to the Electricity shop users. This will minimise the effects to these two businesses.

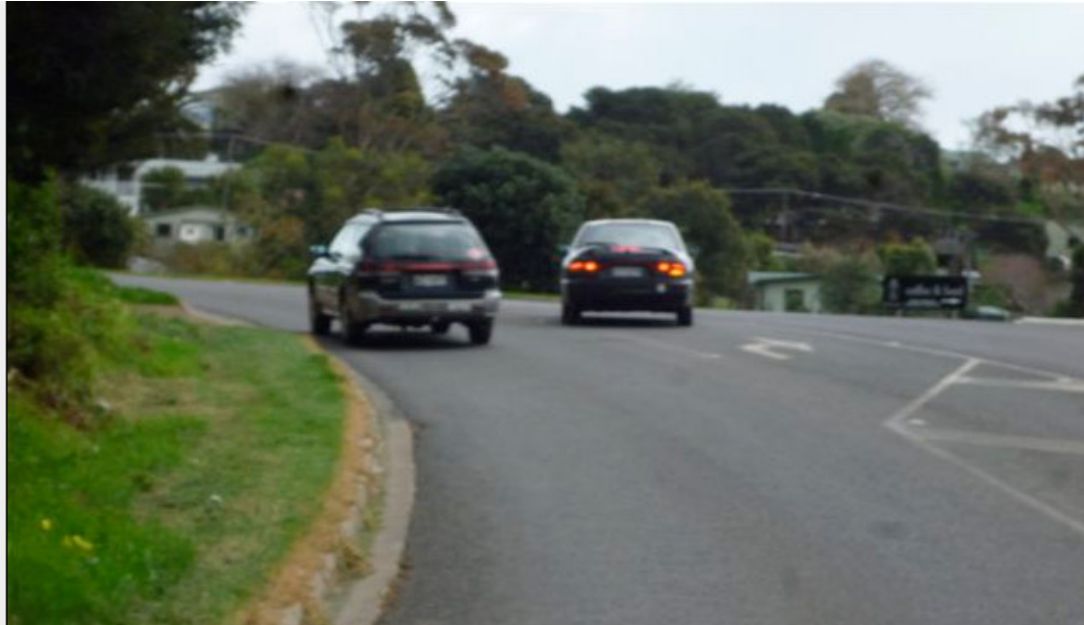
PINCH POINT ASSESMENT SHEET
Action Priority Number: 5.
Location: Ostend Road opposite Placemakers entrance heading uphill westbound
Reason for danger: Right hand turn box into Placemakers blocks safe overtaking of cyclists

When cars sit in the right turn pocket they block the ability for cars to overtake cyclists. This can lead to cars swerving towards cyclists at speed, as they suddenly need to steer and reduce speed to avoid hitting the turning car or the cyclist.

That the Waiheke Local Board request that AT carry out a safety audit on this area. That the widening of the road is considered here to allow a 1.8 metre wide cycle lane on the uphill westbound section of road from Calais Terrace to Seaview Road. If widening of the road is not immediately possible then the reallocation of space by changing the road markings to provide more of the existing width to the uphill lane is recommended as a stop gap approach.

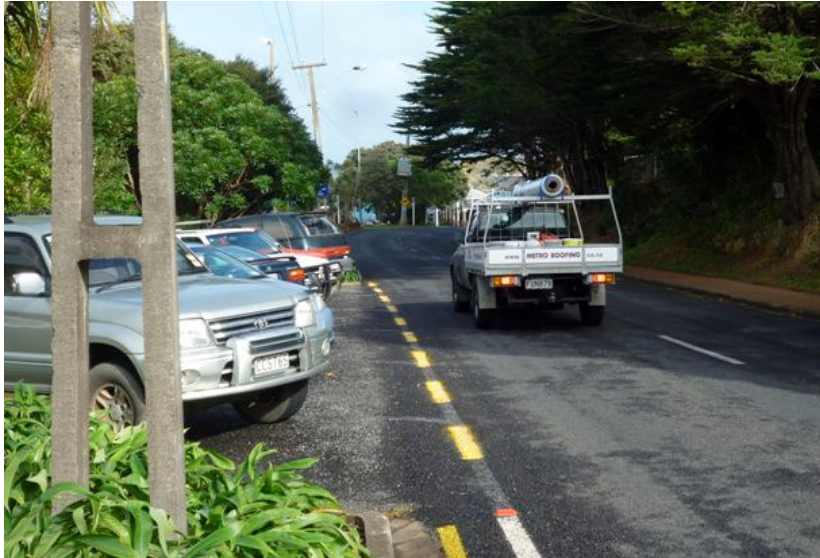
PINCH POINT ASSESMENT SHEET
Action Priority Number: 6.
Location: Ocean View Road westbound
Reason for Danger: Drivers overtaking and pulling out of angled parking squeeze cyclists

Parked cars in the angled parking area can back out into traffic to get better visibility before pulling out. Cyclists are squeezed into the rear of the cars or between them and overtaking cars.

That the Waiheke Local Board request that AT carry out a safety audit on this area. That the angled parking is removed and the area used for safer parking such as for motorbike/mopeds. That if the parking is retained it is changed to "reverse in" angled parking or parallel parking. That the area is made a 30 kph zone and that sharrows are painted in the centre of the lane leading to the ferry terminal.

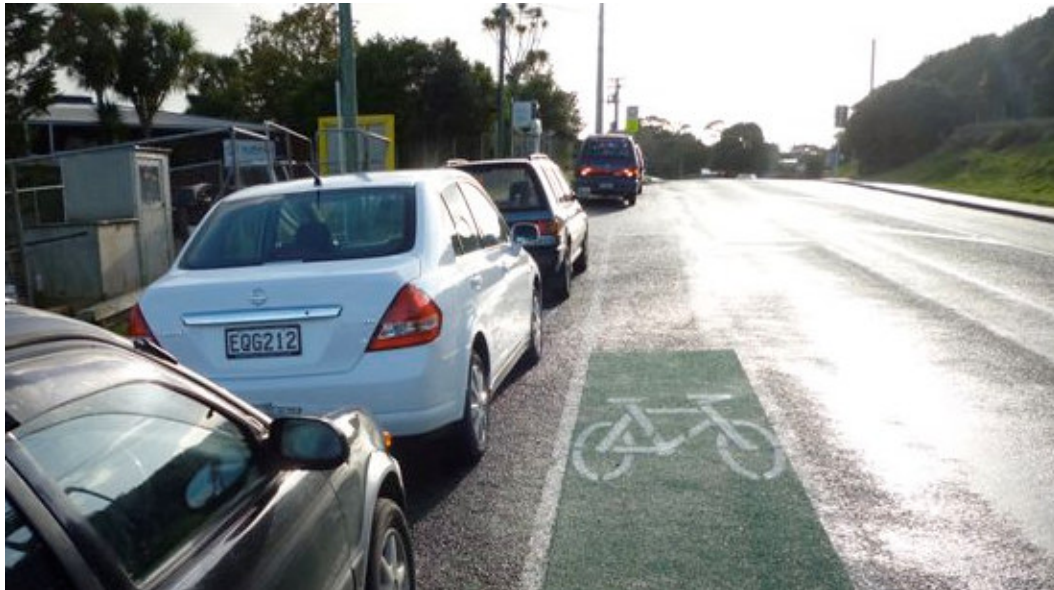
PINCH POINT ASSESMENT SHEET
Action Priority Number: 7.
Location: Donald Bruce Rd Northbound just before the roundabout
Reason for Danger: Cycle lane leads riders into the rear of parked cars.

Cyclists riding in the cycle lane find that it runs out into the rear of parked cars. This happens at the intersection into the kindy where at school times traffic volumes are at peak. Inexperienced school children at risk from being doored here and hit by overtaking cars as they pull out into the live lane to overtake the parked cars.

That the Waiheke Local Board request that AT carry out a safety audit on this area. That three parking spaces outside the kindy are removed and the cycle lane is extended to the roundabout.

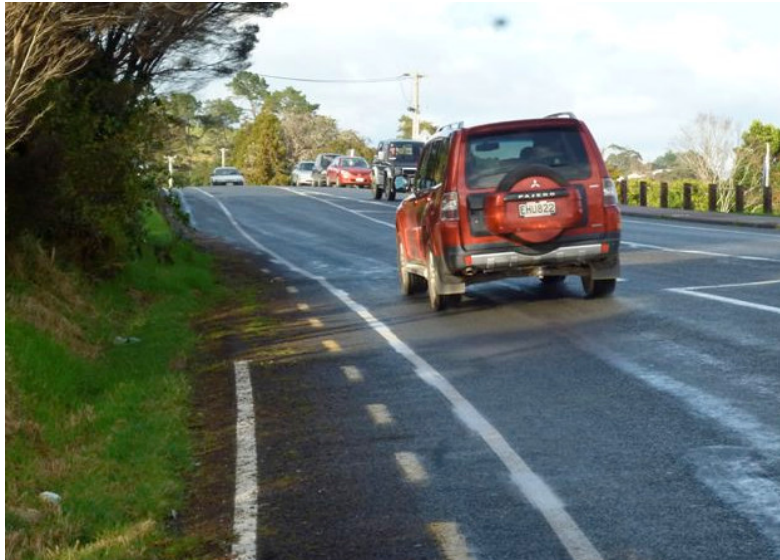
PINCH POINT ASSESMENT SHEET
Action Priority Number: 8.
Location: Donald Bruce Rd southbound opposite the entrance to Waiheke High school
Reason for Danger: Shoulder is narrow and poorly surfaced. Vehicles stray into this area

Cyclists riding in the shoulder are endangered by vehicles that stray into this narrow area when undertaking cars that are positioned in the right hand turn bay into the High school. At school times this area receives high peak volumes and inexperienced child cyclists.

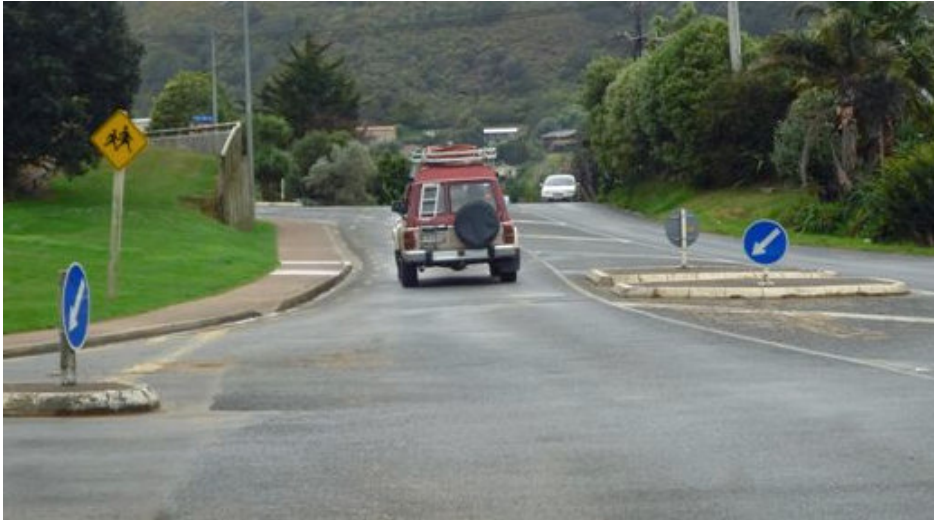
PINCH POINT ASSESSMENT SHEET
Action Priority Number: 9.
Location: Ostend Road heading eastbound just east of Whakarite Rd entrance
Reason for danger: Wide central island area significantly reduced the carriage width

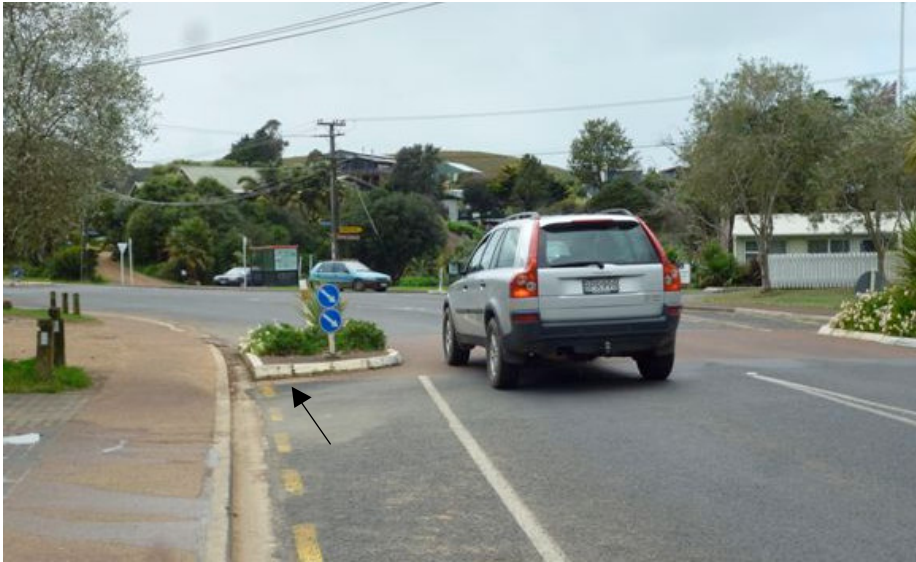
PINCH POINT ASSESMENT SHEET
Action Priority Number: 10.
Location: Belgium Street Outside the RSA eastbound
Reason for pinch point(s): Traffic calming build out narrows carriageway

The traffic calming build out creates a pinch point as cyclists are required to enter the narrow area and cars overtake them here. As riders are going slowly uphill here it is harder for them to claim the whole lane as per NZTA road rules to negotiate the hazard safely.

That the Waiheke Local Board request that AT carry out a safety audit on this area. Create a cycle by pass by reducing the inside width of the planting area (see arrow above). This will allow the traffic calming narrowing to be retained but allow cyclists to by pass the hazard. A cycle lane through the bypass should be painted to encourage use.

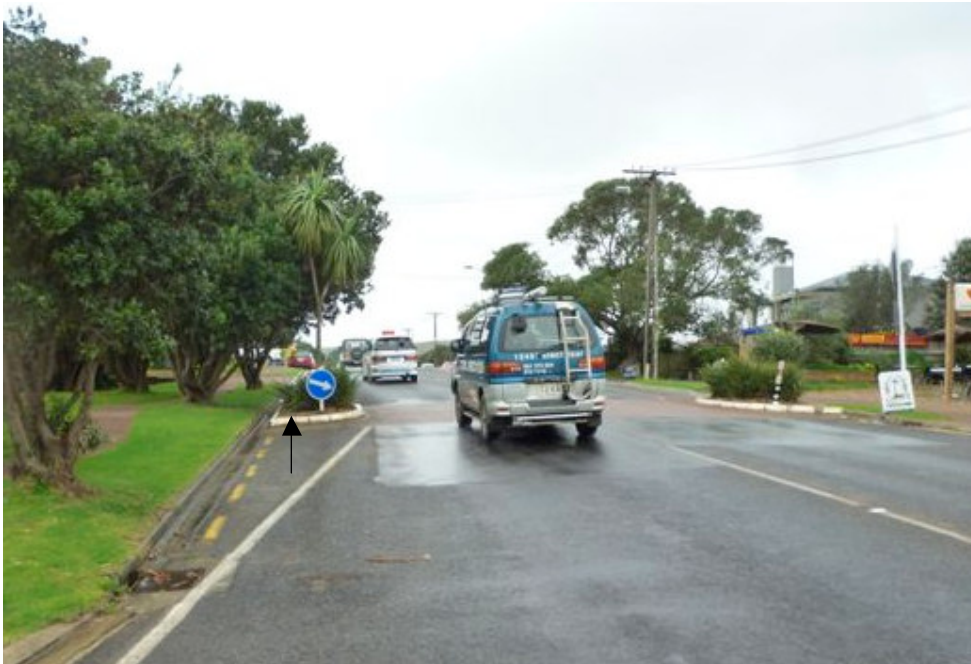
PINCH POINT ASSESMENT SHEET
Action Priority Number: 11.
Location: Belgium Street eastbound
Reason for danger: Traffic calming build out narrows the carriageway

The traffic calming build out creates a pinch point as cyclists are required to enter the narrow area and cars overtake them here. As riders are going slowly uphill here is harder for them to claim the whole lane as per NZTA road rules to negotiate the hazard safely.

That the Waiheke Local Board request that AT carry out a safety audit on this area. Create a cycle by pass by reducing the inside width of the planting area (see arrow above). This will allow the traffic calming narrowing to be retained but allow cyclist to by pass the hazard. A cycle lane through the bypass should be painted to encourage use.

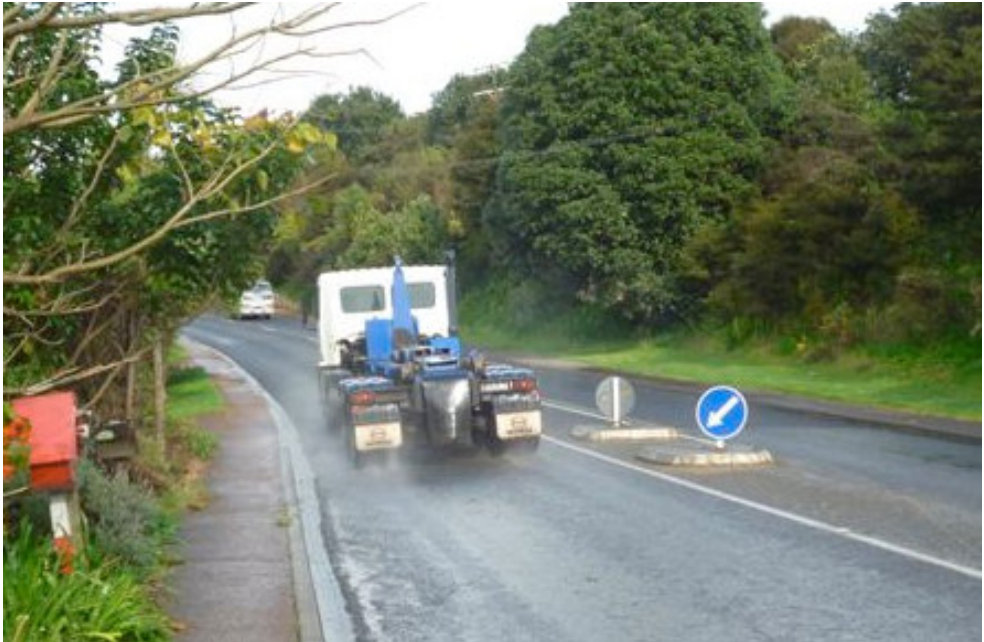
PINCH POINT ASSESMENT SHEET
Action Priority Number: 12.
Location: The Causeway heading eastbound
Reason for danger: Pedestrian refuge island creates pinch point

The central refuge creates a pinch point for cyclists entering the narrow road area when heading downhill eastbound. The refuge is rarely used as it is located too far from Wilma Rd for pedestrians to use and from Causeway Rd is located so that crossing visibility is impaired by the bend and vegetation.

That the Waiheke Local Board request that AT carry out a safety audit on this area. Remove this island refuge and with the new road space create a 1.5 m wide cycle lane on the westbound uphill side. Relocate the crossing point to the apex of the bend on Causeway Rd where the shared cycle/walkway ends.

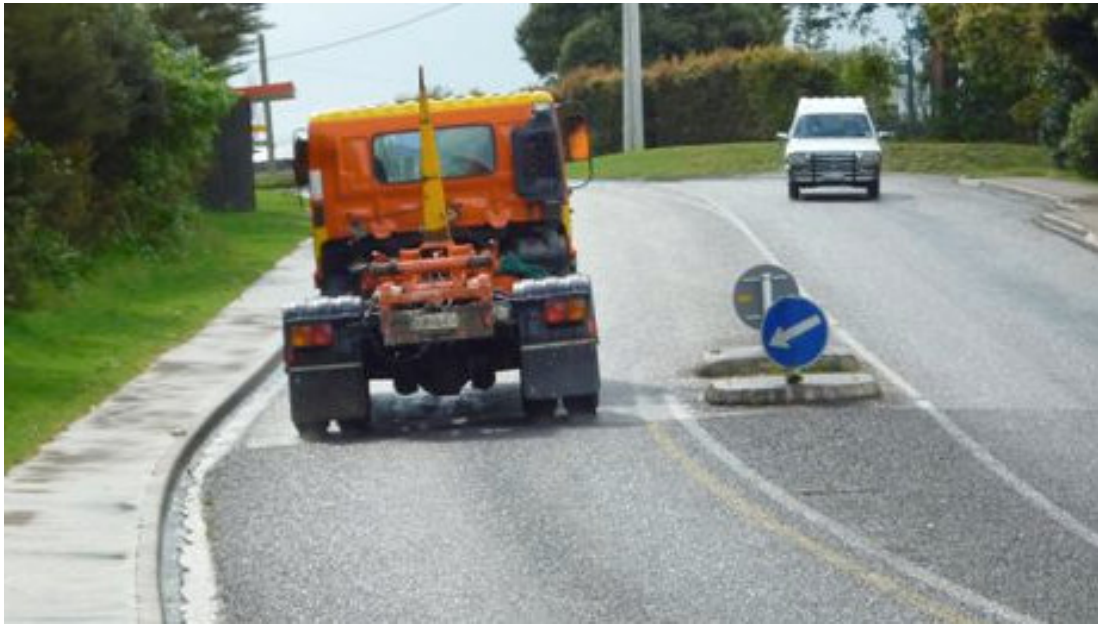
PINCH POINT ASSESMENT SHEET
Action Priority Number: 13.
Location: The Causeway heading westbound
Reason for danger: Pedestrian refuge island creates pinch point

The central refuge creates a pinch point for cyclists entering the narrow road area when heading uphill westbound. Riders are slow here they are in the danger area longer. The refuge is rarely used as it is located too far from Wilma Rd for pedestrians to use and from Causeway road is located so that crossing visibility is impaired by the bend and vegetation

That the Waiheke Local Board request that AT carry out a safety audit on this area. Remove this island refuge and with the new road space create a 1.5 m wide cycle lane on the westbound uphill side. Relocated crossing point to the apex of the bend on Causeway Road where the shared cycle walkway ends.

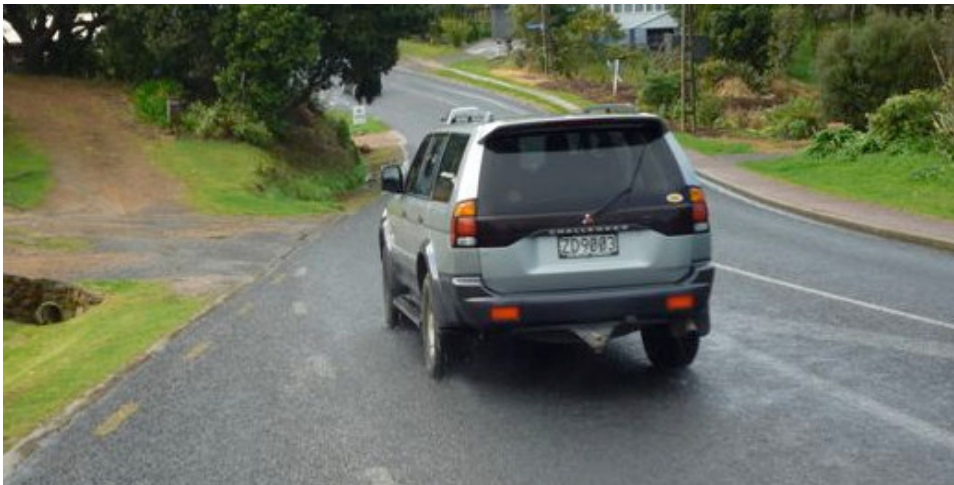
Location: Alison Road eastbound

Reason for danger: The eastbound live lane is too narrow through the intersection and the intersection design is poor- having very fast entries and poor “squaring” as it meets the through road.

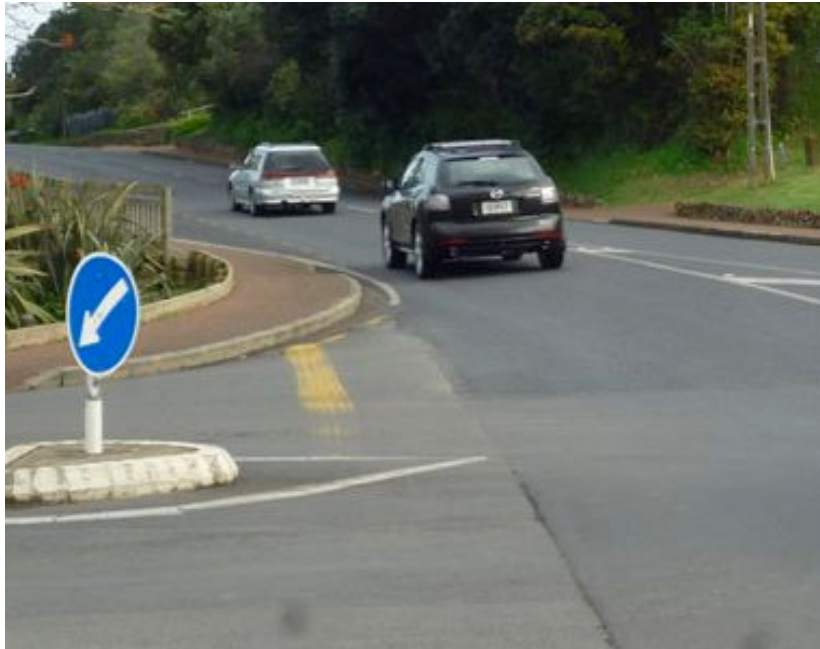
PINCH POINT ASSESMENT SHEET
Action Priority Number: 15.
Location: Ocean View Road west of Moa Avenue
Reason for danger: The road is narrow at this point where the footpath curves into the road just before the bus stop.

Cyclists leaving the painted cycle lane that ends just east of Moa Avenue are led into narrowing of the vehicle lane caused by the footpath as it curves into the road. This forms a pinch point with overtaking cars. This is amplified when cars sit in the flush median turning right into Moa Avenue.

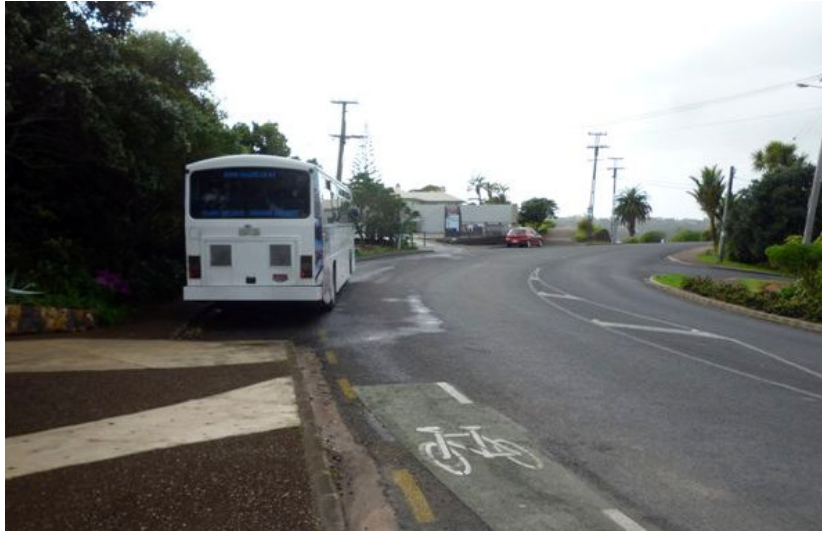
PINCH POINT ASSESMENT SHEET
Action Priority Number: 16.
Location: Ocean View Road just east of Korora Rd outside Artworks
Reason for Danger: Cycle lane stops too soon

That the Waiheke Local Board request that AT carry out a safety audit on this area. Continuation of the painted cycle lane through this parking area with green paint and cycle logos. Door hazards from busses are far less so the lane can go alongside the parking.

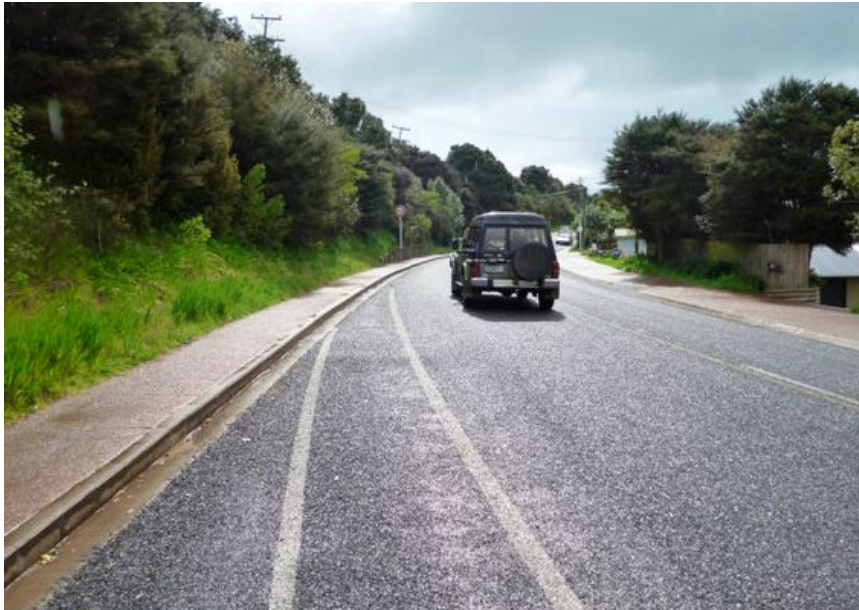
PINCH POINT ASSESMENT SHEET
Action Priority Number: 17.
Location: Westbound on the Causeway
Reason for Danger: Marked cycle shoulder/lane runs out as road narrows

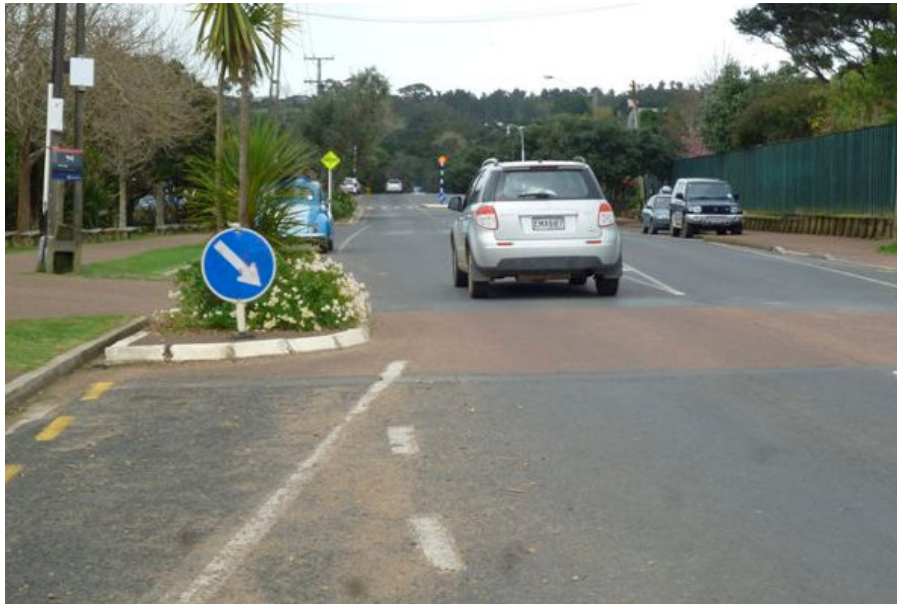
PINCH POINT ASSESMENT SHEET
Action Priority Number: 18.
Location: Westbound on Belgium Street
Reason for Danger: Traffic calming build out narrows the carriageway

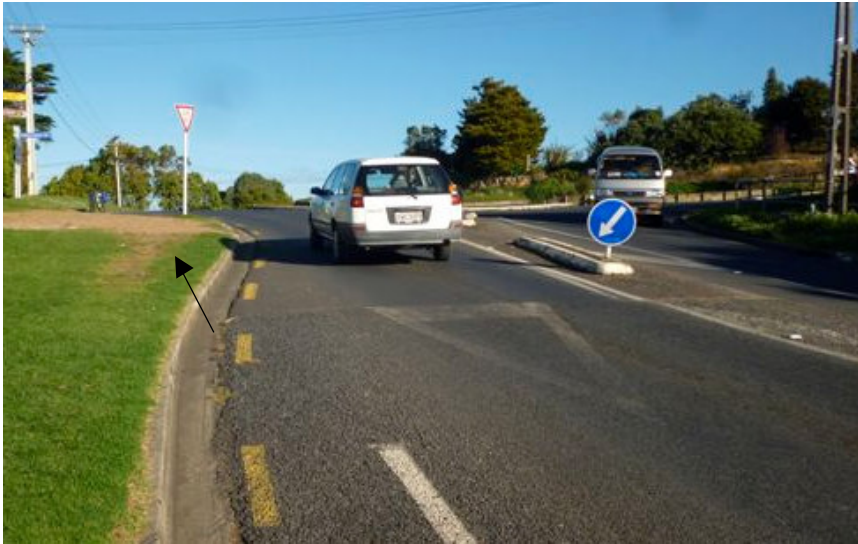
PINCH POINT ASSESMENT SHEET
Action Priority Number: 19.
Location: Eastbound into Donald Bruce Rd roundabout at the end of Alison Rd
Reason for Danger: Road narrows as it enters the roundabout from the cycle lane

That the Waiheke Local Board request that AT carry out a safety audit on this area. That a cycle by pass lane is created here through the kerb area (see arrow above). This will allow the traffic calming narrowing to be retained but allow cyclists to by pass the hazard. A cycle lane through the bypass should be painted to encourage use.
